**DOUGLAS PAUL LEDBETTER &
 JOHNNY RAY LEDBETTER PROPERTY**
 1266 HILHAM HIGHWAY (STATE HIGHWAY 85)
 3RD CIVIL DISTRICT
 OVERTON COUNTY, TENNESSEE
 DATE 25 JULY 2024
 TOTAL ACRES 3.96
 DEED REF: RB 129 PAGE 935
 TAX MAP 52 PARCEL 23.00

Christopher M. Vick, RLS #2164
 VICK SURVEYING, LLC
 2772 Hidden Cove Road, Cookeville, TN 931-372-1286

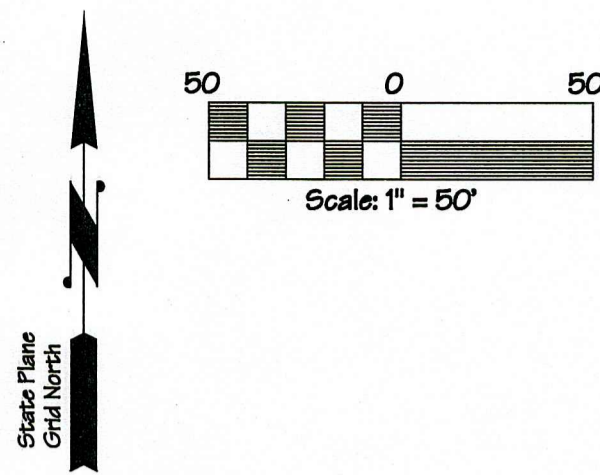
Note: The point of beginning is a ½" rebar (found) being the southeastern corner of this parcel located in the northern right-of-way of Hillham Highway (St. Hwy. 85) as well as being located S 76°28'31" W 195.48 feet from a power pole and furthermore being located N 86°08'45" W 34.07 feet from a GPS Base Point.

LINE	BEARING	DISTANCE
L1	N 05°21'20" W	4.86'
